36-1 Trigger Wheel Alignment

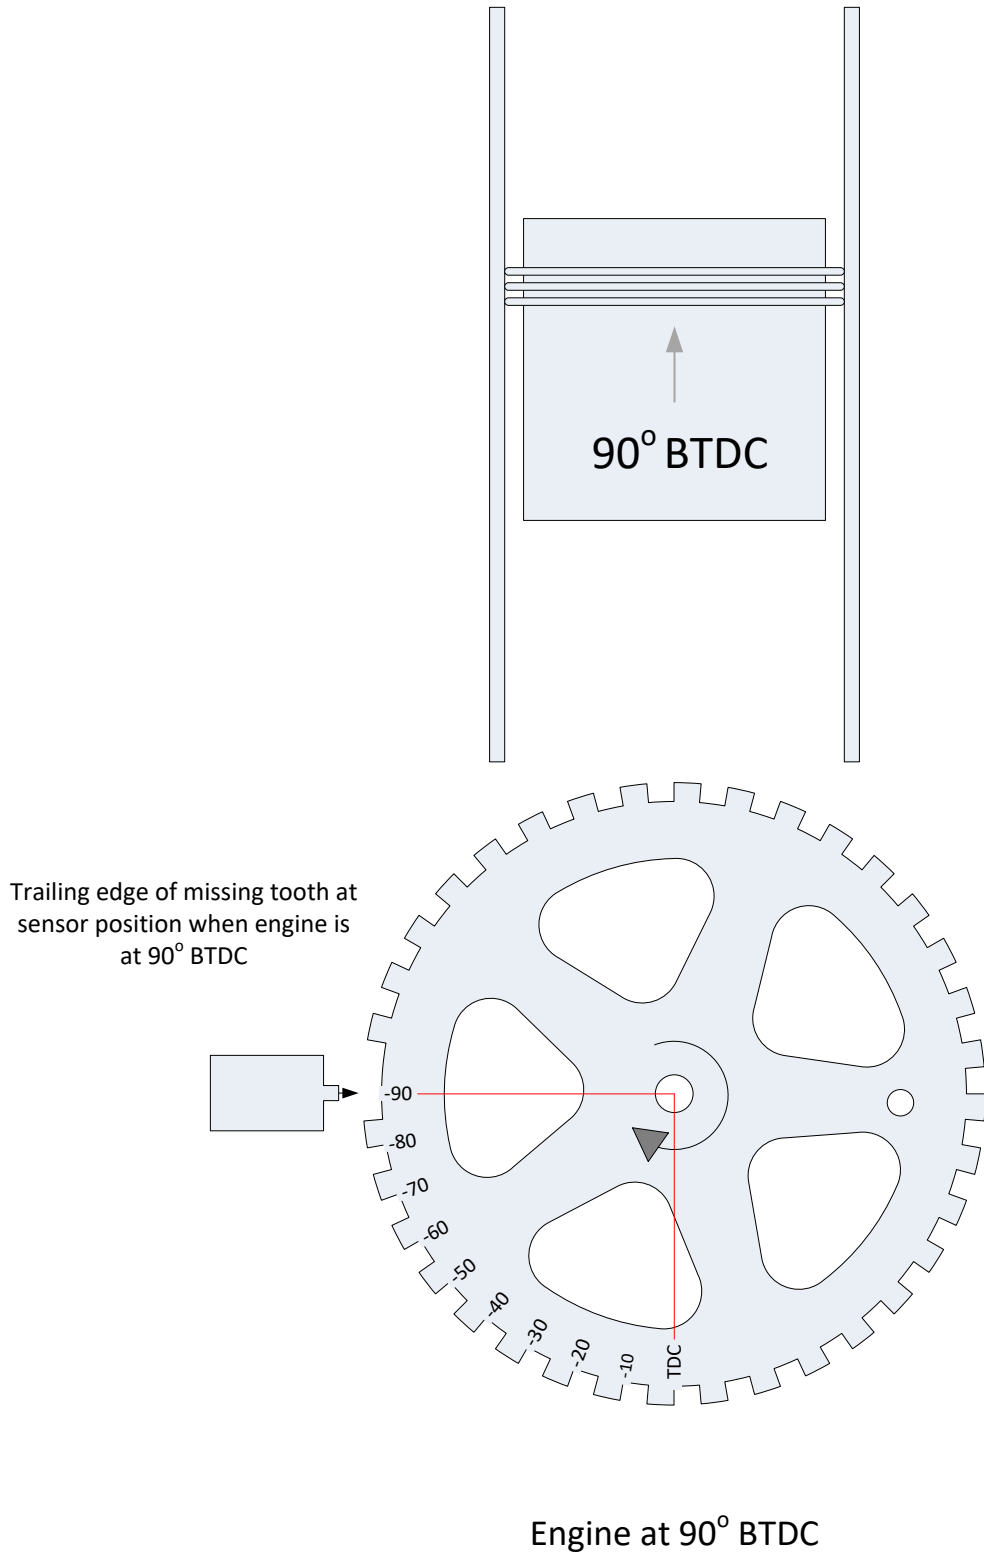
Diagram 1

The crank sensor needs to be positioned such that, with the engine at 90° BTDC on cylinder #1. The centre line of the sensor will be pointing at the missing tooth **trailing edge** - diagram 1.

The clearance between the sensor and the trigger wheel teeth wheel should be 0.89mm ± 0.11mm (35thou ± 5thou).

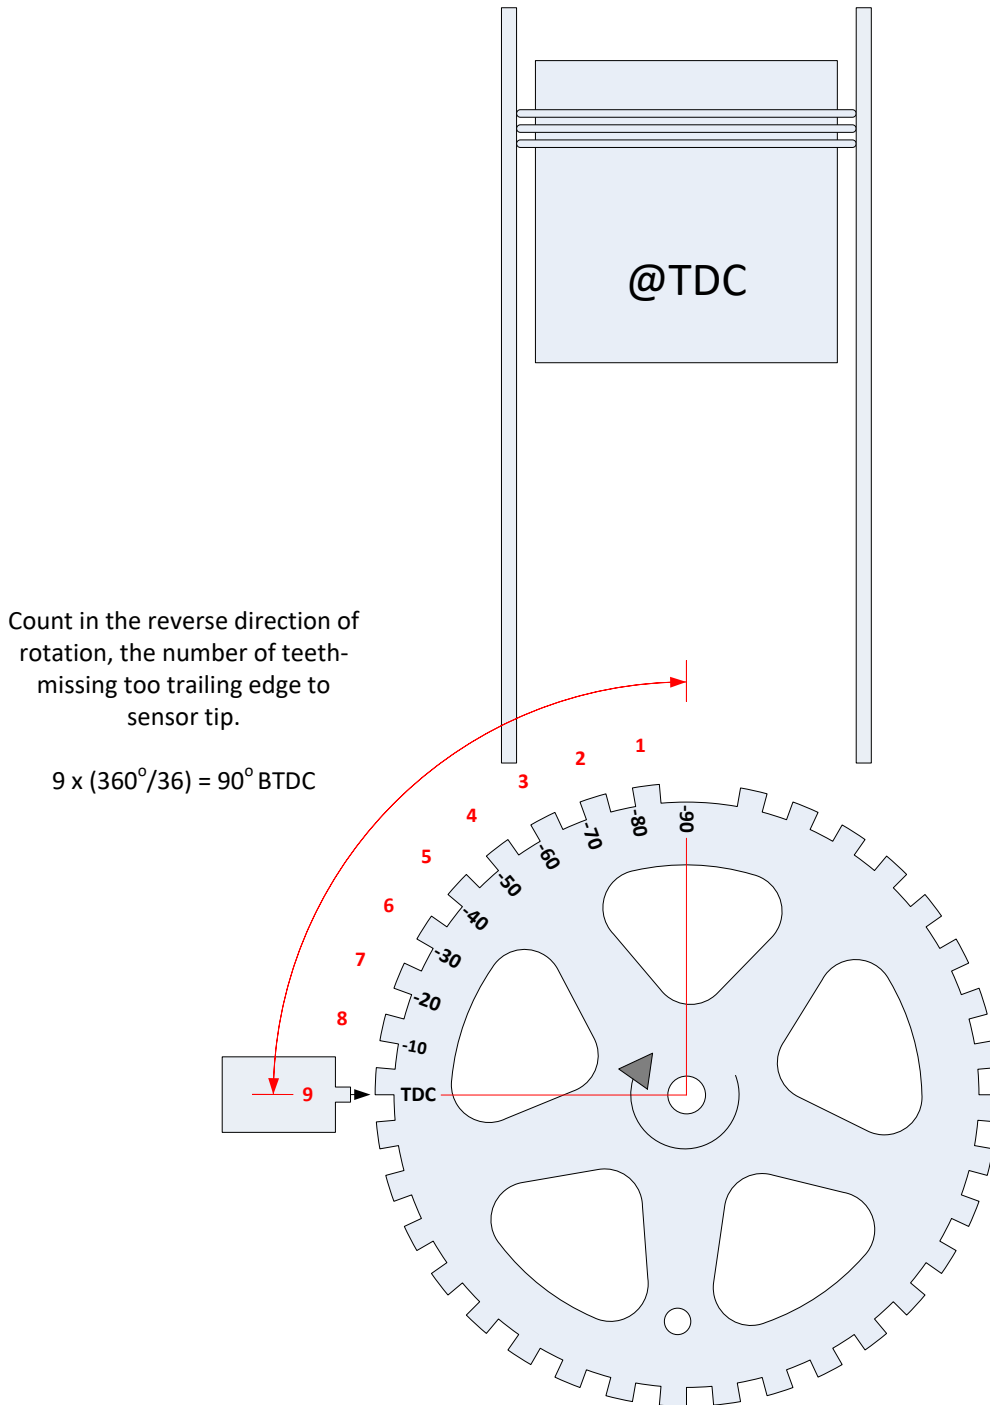
Diagram 2

As it may be difficult to find 90° BTDC on the engine, you can put the engine at TDC and count back the number of teeth to the sensor. In the example below (diagram 2), the missing tooth has passed the sensor by 9 teeth (9 teeth will give you, $9 * 360/360 = 90^\circ$, the ECU’s “Current Reference”).

Engine at TDC

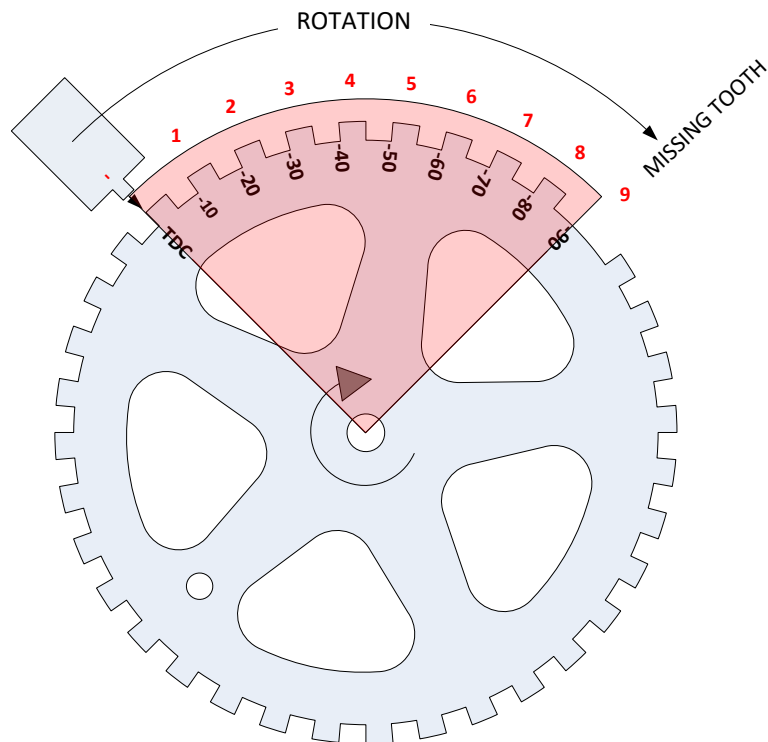
Diagram 3

As a check, with the engine at TDC, the sensor will be pointing at the trailing edge of a tooth. The trailing edge of the (imaginary) missing tooth will then be positioned exactly 90° (9 teeth) away in the direction of rotation. Any error can be corrected in the software as mentioned previously. (Diagram 3).

Engine at TDC

With the engine at TDC, cylinder No. 1: the missing tooth trailing edge is 9 teeth away from sensor.

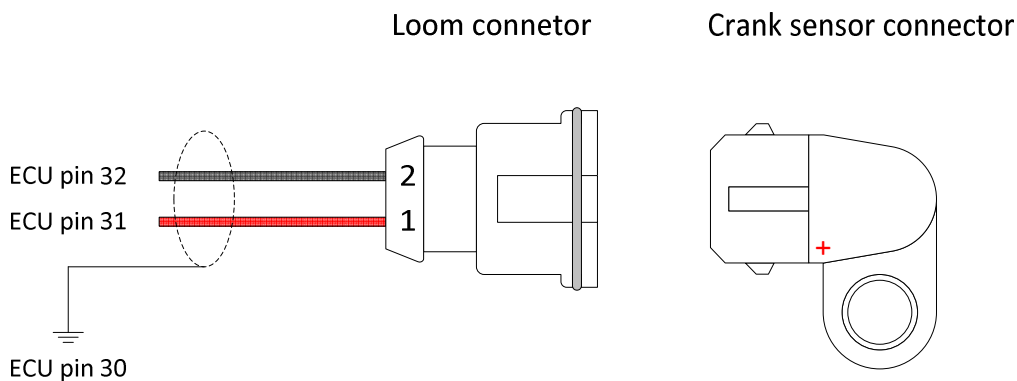
**Ford
Inductive Crank Sensor**

View from cable entry

Terminal	Function	EMR Colour	K6 ECU	NOTES
1	Signal	Red	31	
2	Signal ground	Black	32	
	Screen	Slate	30

Screen connected to ground at ECU end ONLY
